ENVIRONMENTAL RISK ASSESSMENT SURVEY:
BRIGHTON LANDFILL
BRIGHTON, ILLINOIS

Job No. 916.4

March 21, 1985

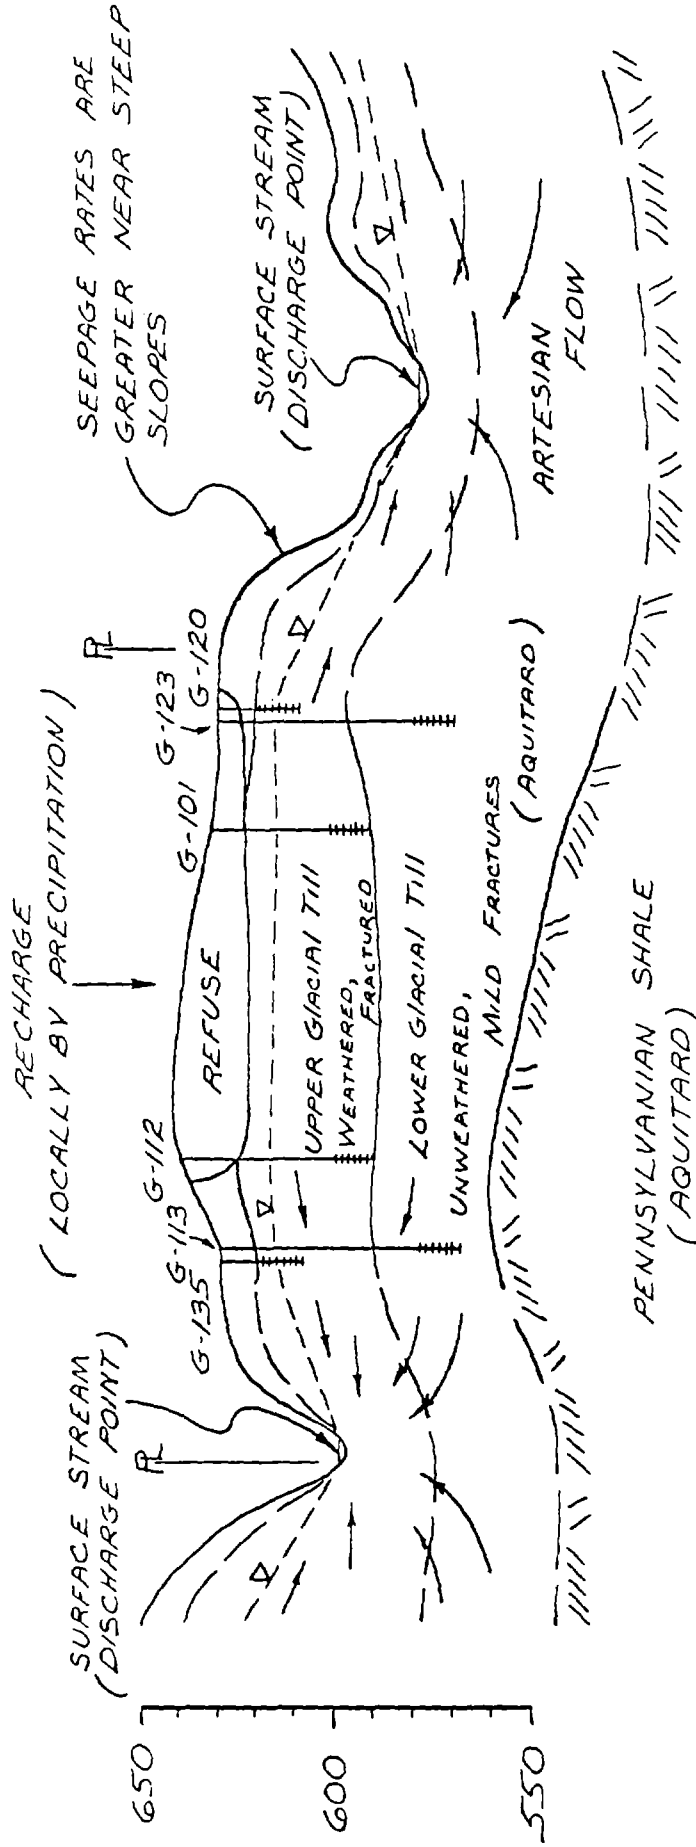
SITE HYDROGEOLOGY

A total of 37 falling head permeability tests have been performed on samples at the site; 30 of these were performed on samples obtained during the latest program of investigation. These tests indicate permeabilities consistently in the 10^{-8} cm/sec range for the cohesive till and permeabilities in the 10^{-6} cm/sec to 10^{-7} cm/sec range for the occasional loamy sands encountered. Site hydrogeology is depicted in Figure 4.

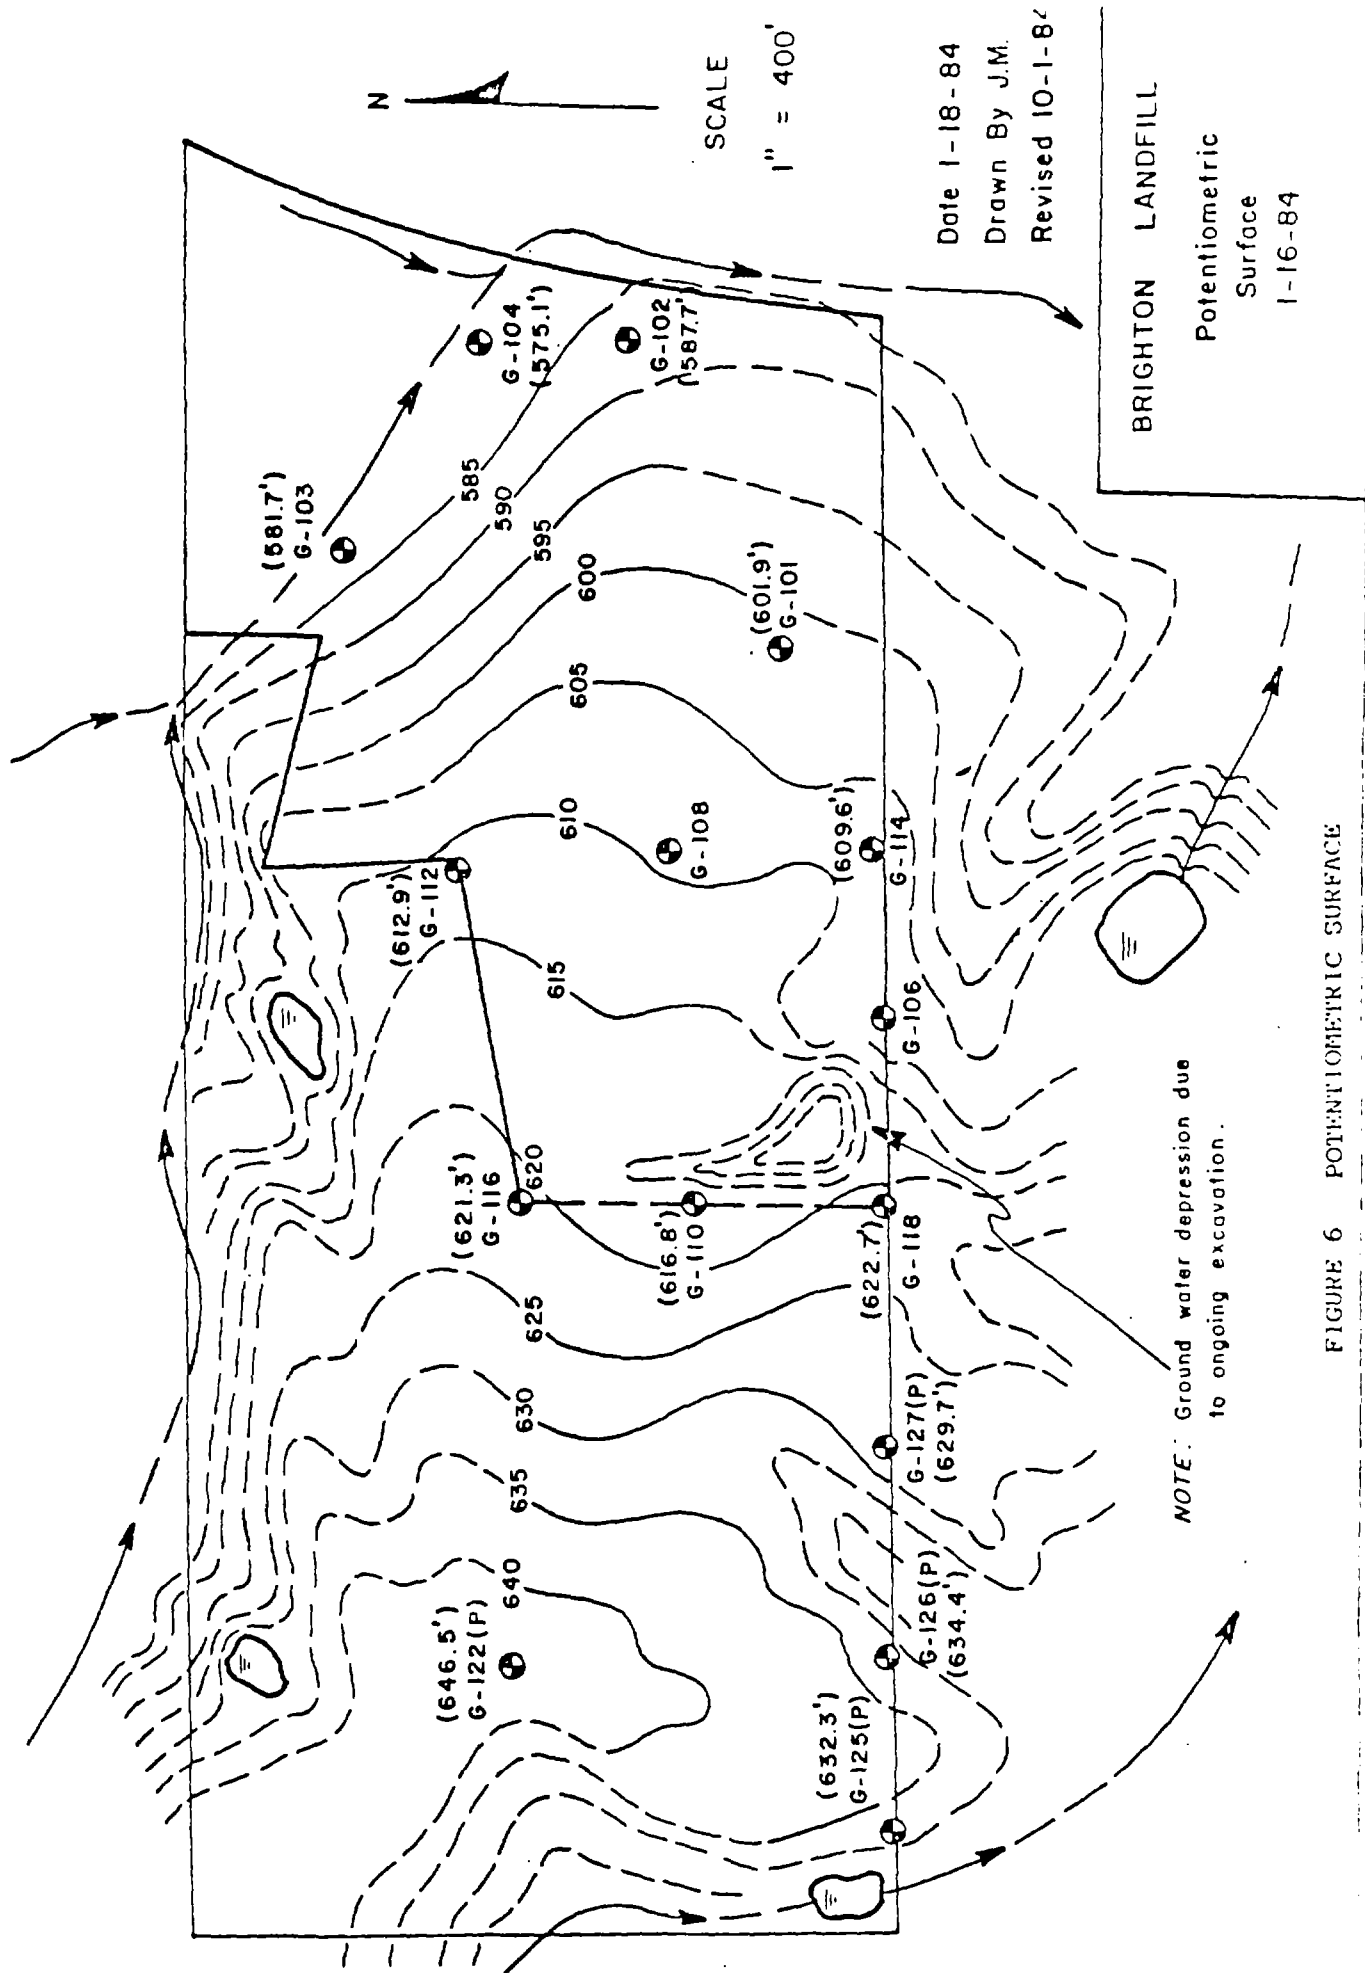
FIGURE 6 POTENTIOMETRIC SURFACE

Groundwater flow at the site and in surrounding areas generally corresponds to surface topography. Consequently, flow is multi directional. This can be seen on the site map and is further illustrated in the potentiometric surface map (Figure 6).

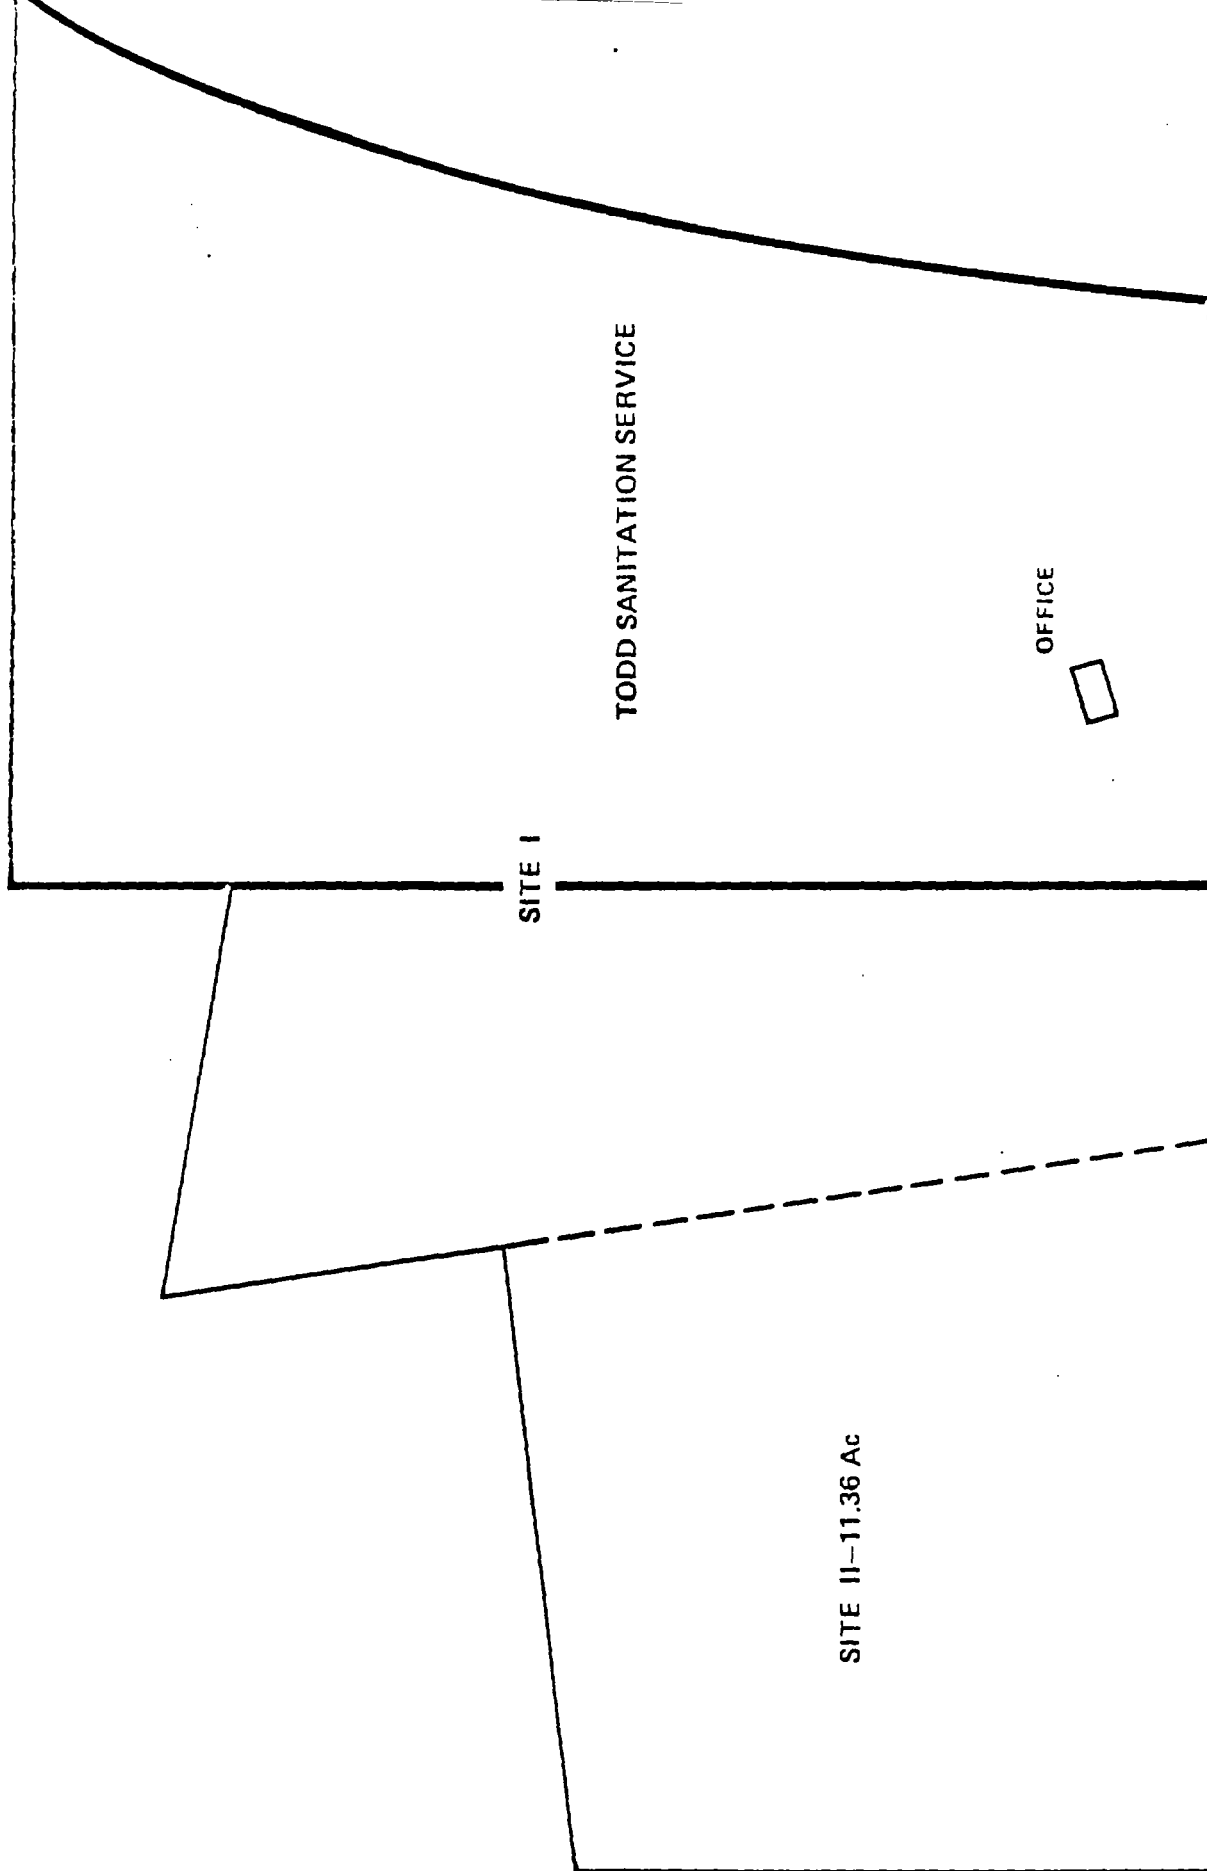
Figure 10. Brighton Landfill - 1971

no leachate collection system has been installed, nor is the excavation complete. The complete conditions of this supplemental permit are contained in Appendix C. Some scope of the future operations can be gained from a review of Figure 12. It should be noted that the portion of the facility (partly in Site I and partly Site II was used after November 19, 1980) is subject to RCRA closure requirements but has never gone thru closure. The State of Illinois is not requiring an artificial liner for the 60 ft. deep trenches. Waste material is now being "stockpiled" in 18 feet deep x 3.5 feet wide trenches awaiting the construction of the final burial vault now being excavated in the southwest corner of Site II. Information on the material accepted by Brighton Landfill for disposal is contained in Appendix C. The complete history of environmental monitoring and compliance is the subject of Section 4.
